## TECHNICAL BULLETIN

### NISSAN – PULSAR ET / EXA TURBO

#T0025

**Subject:** ECM terminal connections

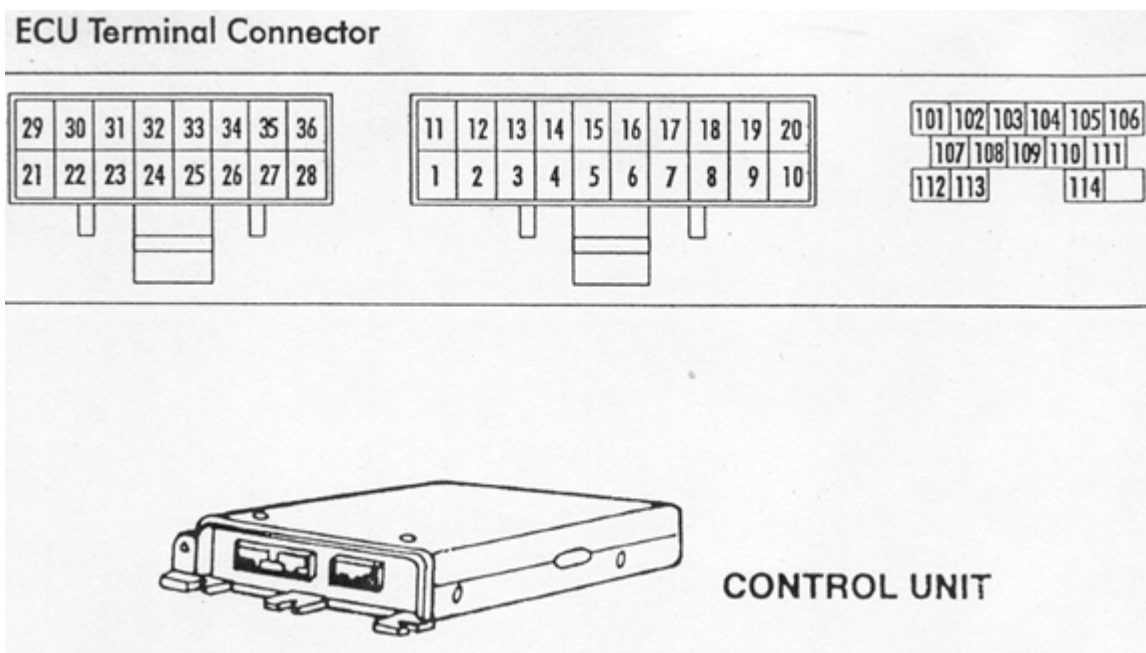
The 1984 - 85 ET Pulsar and the 1983 - 85 Exa Pulsar both utilise a 1.5L E15ET Turbo charged engine. Injctronics has been asked to supply an exchange ECM on many occasions, when in fact the ECM was not the fault. A common complaint is that when accelerating hard and boost starts to come in, the vehicle will only rev up to approximately 3000 RPM and then hold back.

Technicians have also unnecessarily replaced fuel pumps as the problem feels like a lack of fuel. What has been found however, is that poor terminal connections at the ECM have been at fault. The ECM is situated under the passenger seat and suffers from vibration and corrosion on the terminals. Simply by removing the plugs and spraying them with a corrosion / deoxidiser, then a protective spray and by pushing the plugs in and out of the ECM several times the problem is rectified.

NB: Often tightening or crimping of the harness female terminals is required for a better connection.
