PRODUCT SERVICE INFORMATION

Document number: P0017

Vehicle: Toyota RAV4 / Avensis

Subject: PCM Installation instructions

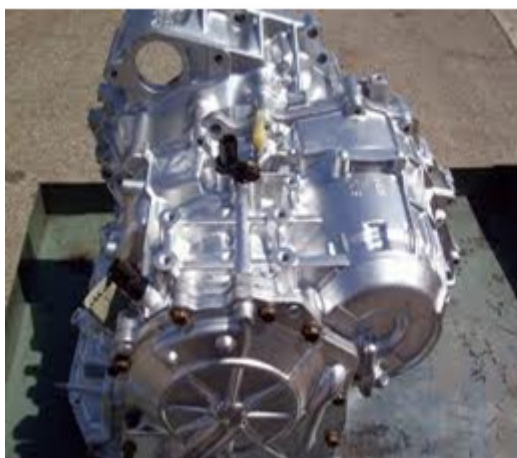
2001-2003 Toyota RAV4 Shift Solenoids Assy

Upon diagnosis, it has been found that the ECM does not fully release the (SLT) direct clutch solenoid. This clutch is applied on the 2nd to 3rd gear change. To test for this condition, connect a pressure gauge to the direct clutch pressure port. Shift solenoid SLT is used to alter fluid pressure to the direct clutch. When driving in 3rd gear there should be pressure (approx. 120 Psi) seen on the gauge. In 2nd and 4th there should be a zero pressure reading on the gauge. If there is any pressure seen on the gauge in 1st, 2nd or 4th, it is a sign that the ECM has failed. If it has slight pressure whilst in 1st, 2nd or 4th gears (3 to 20 PSI), it is enough to keep the direct clutch slightly applied and will cause it to eventually burn out.

Replace the ECM (situated behind glove box compartment) as per manufacturer instruction. Test drive the vehicle from cold to normal operating temperature to confirm fault has been rectified. If the fault condition is still present after replacing the ECM, the automatic transmission direct clutch assembly may also require replacement due to having been driven for too long whilst in a partially applied state.
