## TECHNICAL BULLETIN

### FORD KE LASER / MAZDA 323

#T0028

**Subject:** No ignition

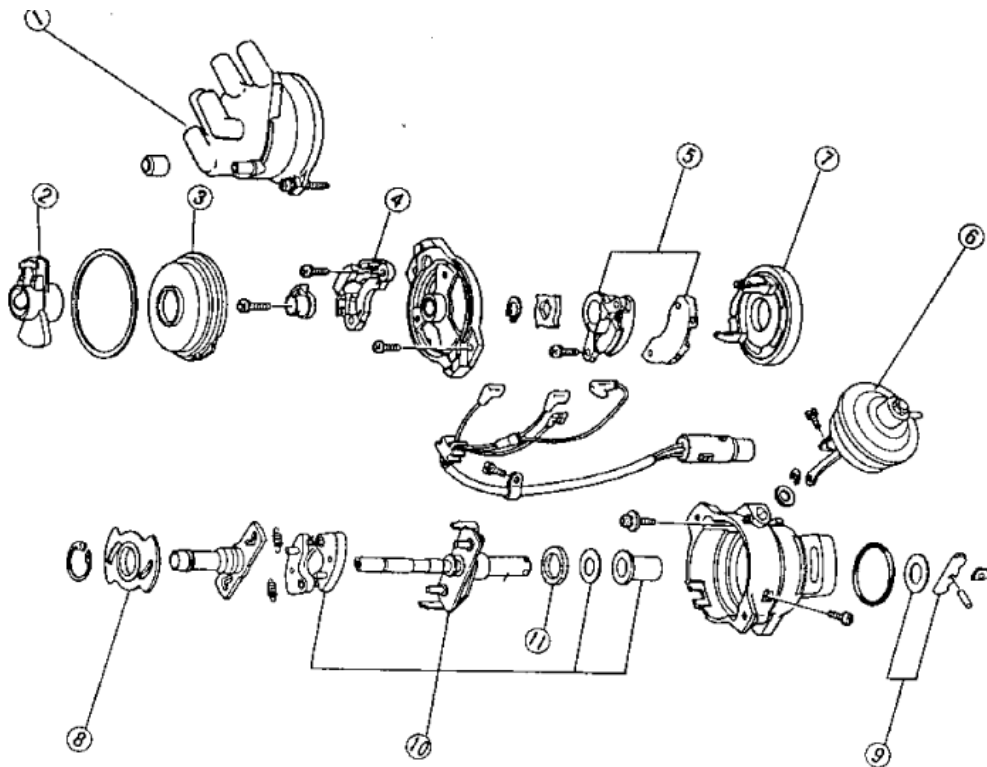
Injectronics has experienced a number of times, technicians fitting the incorrect parts to Ford / Mazda 1.6L turbo distributors causing no ignition. The distributor looks like it has 2 Ignition modules but in fact there are 2 sensors. The top sensor is a Mitsubishi J911 and it is called the G sensor. It has 2 terminals marked 'B' for battery power supply and 'G' for G sensor, which provides a pulsed earth as the distributor turns.

The bottom or lower module is only a terminal block and does not have any electronics in it. It is a direct connection to the inductive wheel sensor and windings and provides a terminal block for the wires going out of the distributor to the ignition / knock control module mounted on the drivers side ground.

Technicians often fit the J117 ignition module in place of the terminal block (as it looks identical) from non turbo distributors which will not operate. To check if the correct module / terminal block are fitted to the distributor, check there is continuity from the pickup winding terminal to the wire connection terminal on both sides of the module / terminal block.
