# Injectronics

## TECHNICAL BULLETIN

### BMW E85 Z4 2.0L ROADSTER – POWER STEERING #T0139

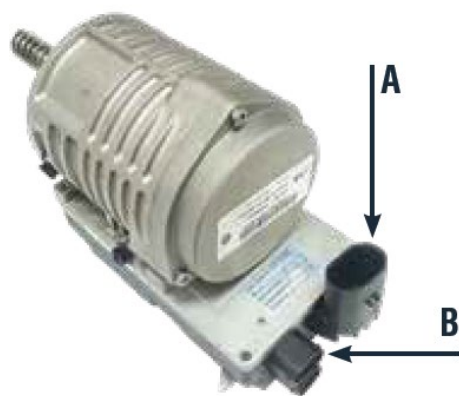
If vehicle is presented with the EPS warning lamp continuously on and no scan tool communication with EPS module, repairers are advised to check for power supply and ground circuit to ensure that EPS system is getting the power feed. Basic pin configuration is provided in this image. If any of the power supplies are missing, then please check the circuit and relevant fuses. After confirming that the EPS system supply and ground circuit is OK and scan tool communication is still not possible then the EPS unit may have an internal fault.

#### Connector A

RT Wire - Batt 12V  
BR wire - GND

#### Connector B

Pin 5 (GN/WS) - IGN Key ON 12V  
Pin 1 (GE/BR) - CAN BUS L  
Pin 4 (GN/WS) - CAN BUS H

Injectronics can provide a prompt and cost effective repair service of customer's own EPS unit. To fully repair the EPS unit, Injectronics requires the EPS motor assembly only (please be aware to follow correct manufactures removal and assembly instructions when disconnecting the EPS unit from the steering column assembly).
