TECHNICAL BULLETIN

#T0040

Model: Commodore VS V6

Subject: Oxygen sensors

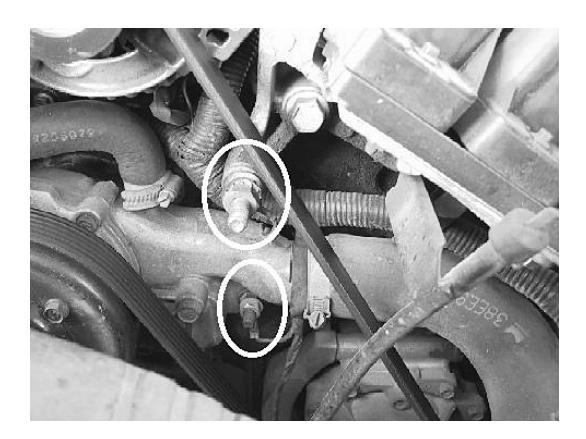
At Injectronics we often receive calls regarding VS Commodores, from mechanics complaining about one bank of injectors (V6) running richer than the other. Apart from occasional ECM faults, the most common fault is with the oxygen sensor earth points. The VS V6 is fitted with two zirconia tipped oxygen sensors, located in the front engine pipes which should begin to operate in closed loop once exhaust temperature has reached approximately 320°C. Each sensor has its own individual earth point, one being on the DFI module mounting stud and the other being on the engine front cover as seen in diagrams below. These earth points correspond to PCM terminals D14 and D16 (sensor reference grounds) and when tested should always be below 0.1 volts.

V6 DIS Module mounting stud

(top circle)

V6 Engine front cover (bottom circle)

It is imperative that these earth points are clean and below 0.1 volts as the ECM compares the 02 sensor voltage signal to the earth point and if this earth point or reference is not at zero volts the ECM will not trim the fuel mixture correctly. If these earth points (PCM terminal D14 or D16) are at a different voltage levels, it will result in a different fuel trim for each bank.
