PRODUCT SERVICE INFORMATION

Document number: P0017

Vehicle: Toyota RAV4 / Avensis

Subject: PCM Installation instructions

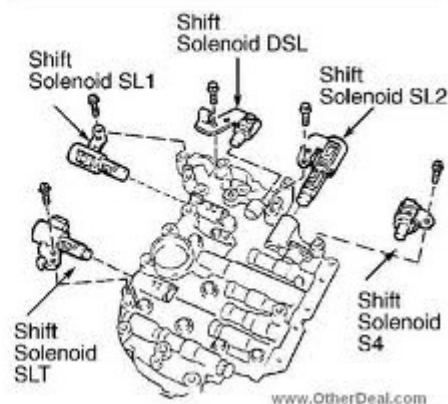
2001-2003 Toyota RAV4 Shift Solenoids Assy

Some 2001 – 2003 model RAV4 vehicles equipped with an automatic transmission may exhibit a harsh shift condition during normal driving or even when putting into gear, and/or M.I.L. (malfunction indicator lamp) "ON". Upon checking fault codes, often the following DTC's are present: DTC P0750 (transmission shift solenoid A malfunction), DTC P0753 (transmission shift solenoid A electrical), DTC P0755 (trans shift solenoid B malfunction), DTC P0758 (transmission shift solenoid B electrical), and/or DTC P1760 (shift solenoid SLT malfunction) stored.

Upon diagnosis, it has been found that the ECM does not fully release the (SLT) direct clutch solenoid. This clutch is applied on the 2nd to 3rd gear change. To test for this condition, connect a pressure gauge to the direct clutch pressure port. Shift solenoid SLT is used to alter fluid pressure to the direct clutch. When driving in 3rd gear there should be pressure (approx. 120 Psi) seen on the gauge. In 2nd and 4th there should be a zero pressure reading on the gauge. If there is any pressure seen on the gauge in 1st, 2nd or 4th, it is a sign that the ECM has failed. If it has slight pressure whilst in 1st, 2nd or 4th gears (3 to 20 PSI), it is enough to keep the direct clutch slightly applied and will cause it to eventually burn out.

Replace the ECM (situated behind glove box compartment) as per manufacturer instruction. Test drive the vehicle from cold to normal operating temperature to confirm fault has been rectified. If the fault condition is still present after replacing the ECM, the automatic transmission direct clutch assembly may also require replacement due to having been driven for too long whilst in a partially applied state.
