FORD RANGER / MAZDA BT50

#T0149

Subject: No left hand side low beam

Injectronics TECHNICAL BULLETIN

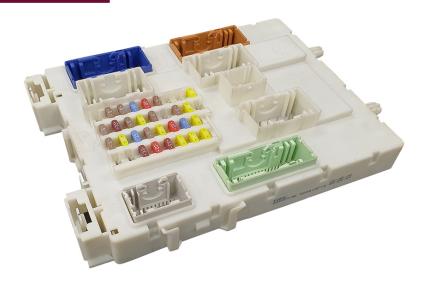
Injectronics only require the BCM for testing and repair of the above listed faults. The BCM is located on the driver's side of the vehicle underneath the dash panel.
