TECHNICAL BULLETIN

DAEWOO - CIELO

#T0076

Subject: No start

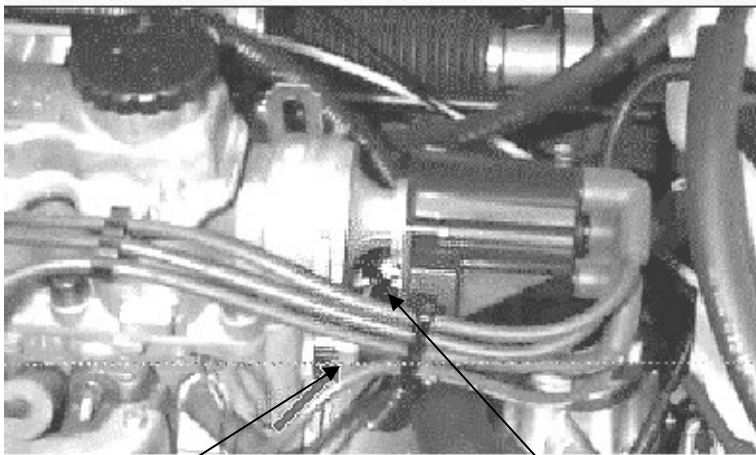
The problem was traced back to the coolant temp sensor and the distributor, they sit beside each other on the vehicle, both have identically shaped pin plugs, if the plugs are swapped around the vehicle will not start. The easy solution is swap the plugs back around, generally no damage occurs to the engine ECU, if any further problems occur the ECU can be tested by Injectronics.

Coolant sensor plug

Distributor plug
